Re: RRGL Review – Big Hole Ditch Improvement Project

**Applicant Name**     **Beaverhead Conservation District**

**Project Title**        **Big Hole Ditch Improvement Project**

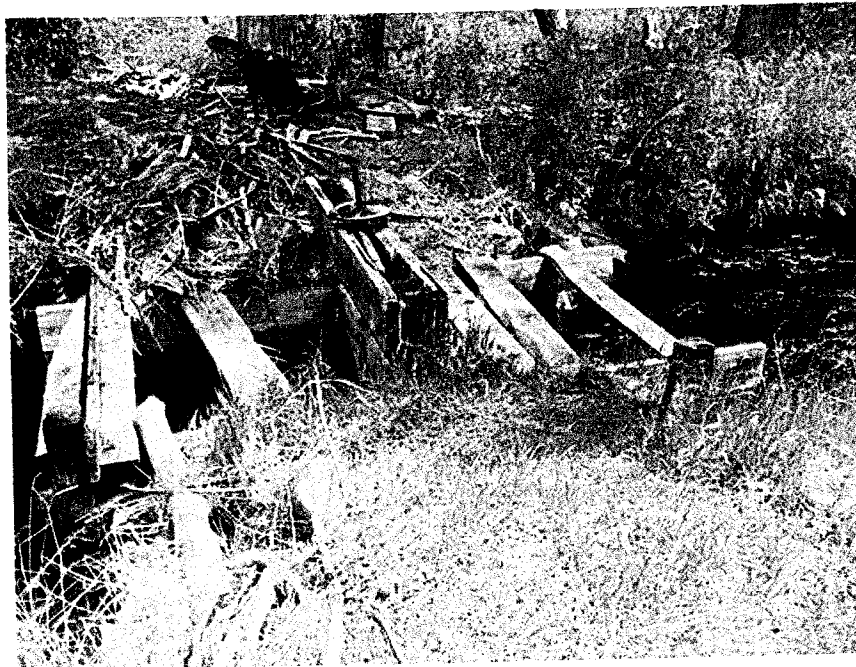
**Site 1. Headgate at Rock Creek is a fish barrier and does not provide adequate control of water (leaky headgate).**

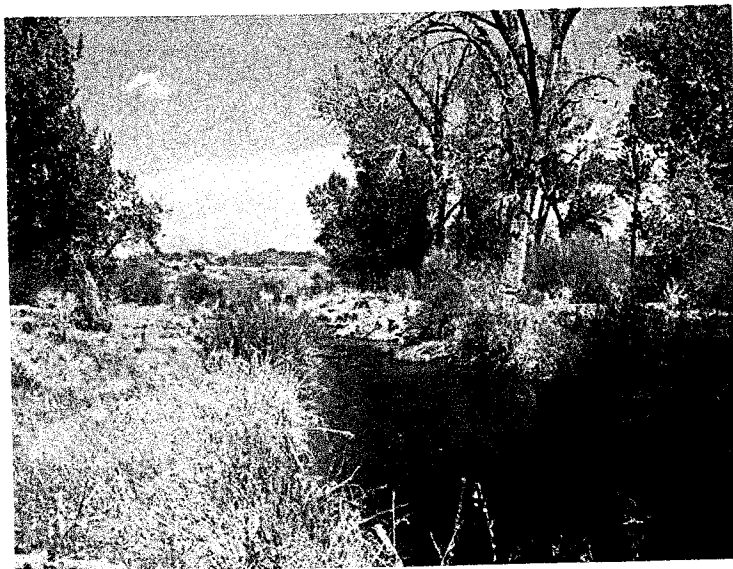
**Ditch upstream from site 1 is often blocked by beaver leading to danger of breach into Big Hole River directly below (to right). A redesigned control structure at site 1 would prevent Rock Creek water from backing up into ditch, allowing the ditch to dry during non-irrigation season (currently not possible) eliminating that problem altogether.**

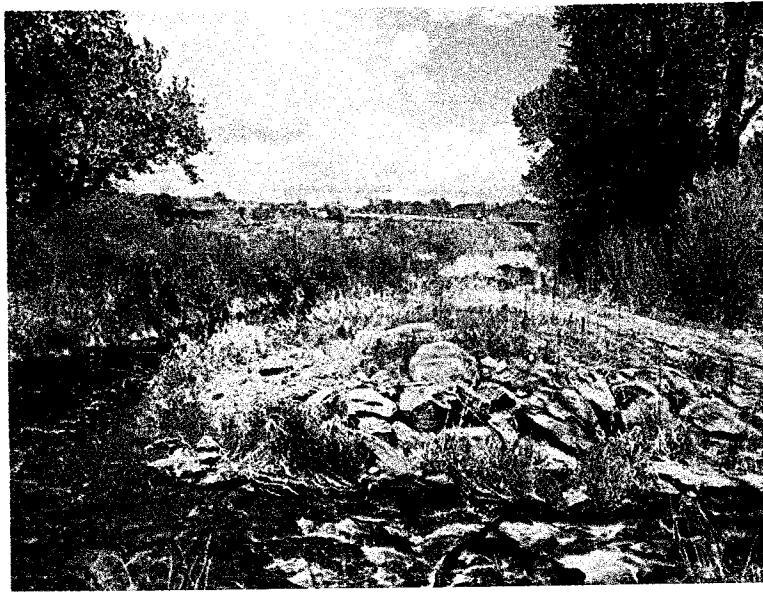
**Site 1. Overflow structure at Rock Creek. Ditch and creek intercept at this location. Interstate visible in background. Rock Creek flows up into Big Hole Ditch as far as the interstate. Therefore the ditch holds water whether or not irrigation is occurring. This situation permits beaver and muskrat to winter in the ditch and create overflow or breach situations in the ditch wall.**

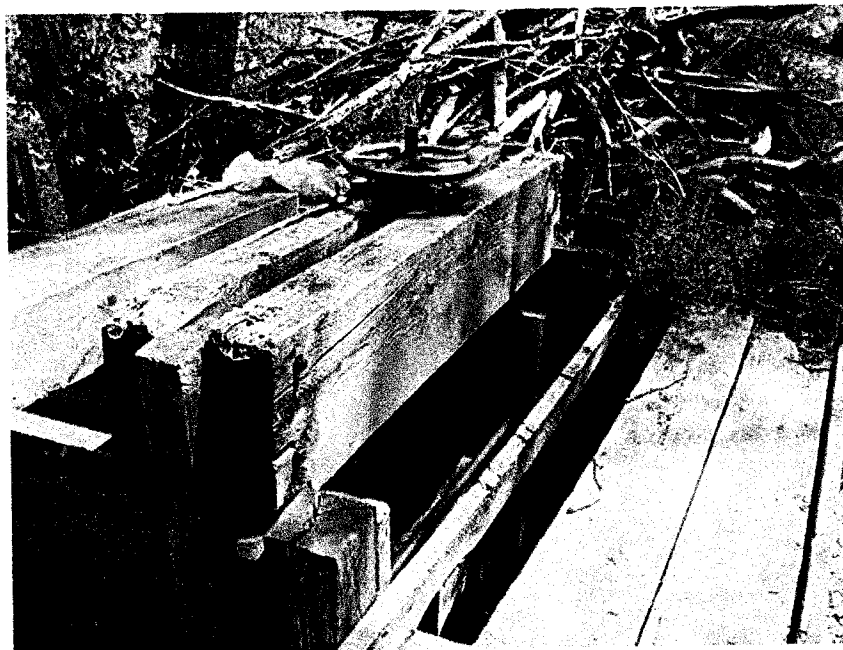
**Site 4. View of upper control structure. Leaky headgate provides little control of water at this structure and serves as fish passage barrier. Most importantly, this structure must withstand huge flow pressures (note size of diversion in site 6 photo).**

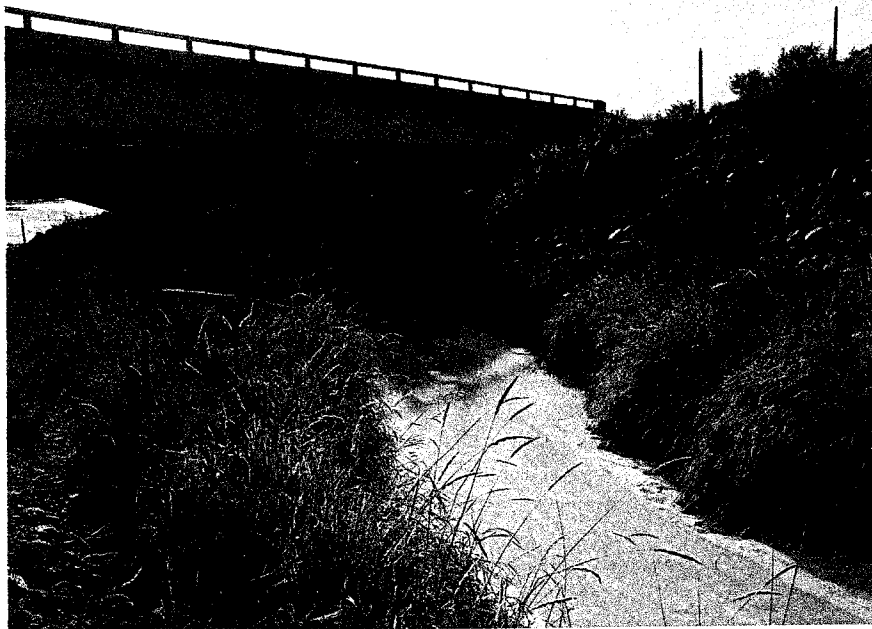
**Site 2. Big Hole Ditch entering 384-foot culvert beneath Interstate 15**

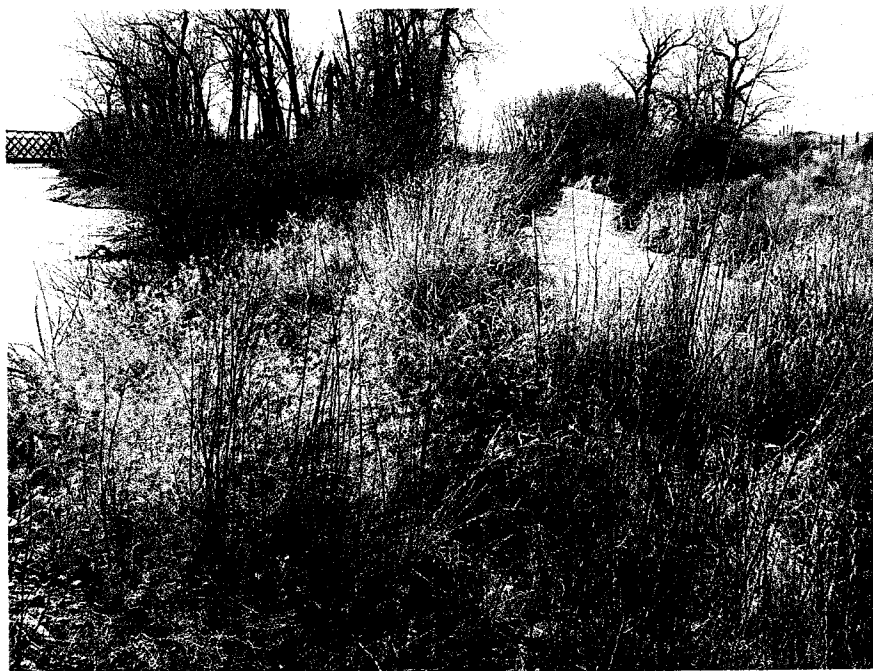
**Site 3. Proximity of Big Hole Ditch to Big Hole River threatens water quality and public safety in the event of a breach.**

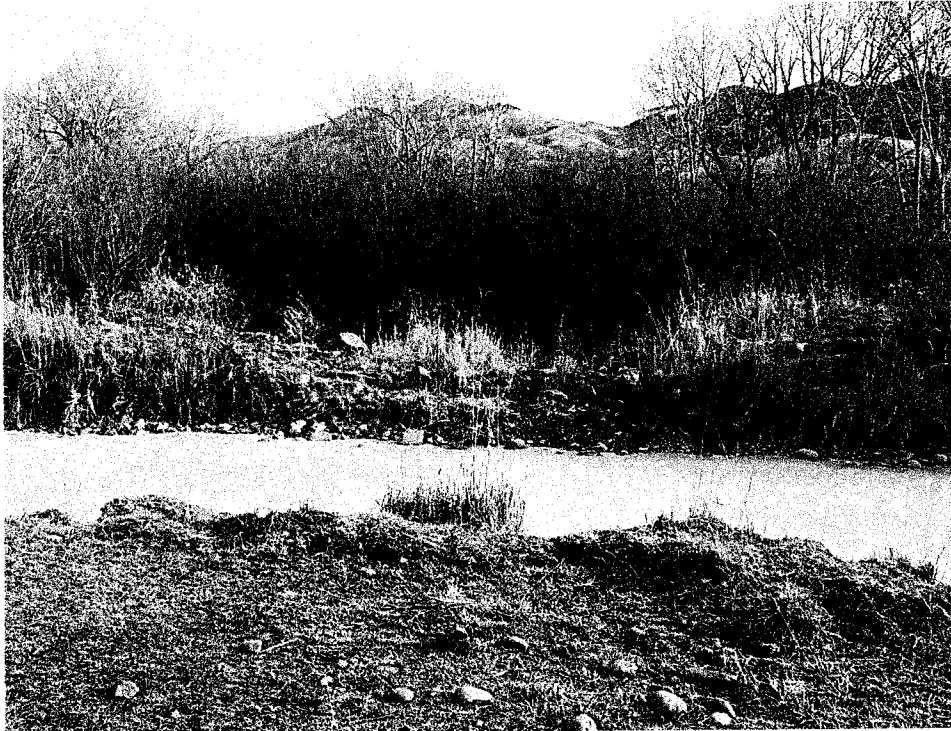
**Site 3. Spillway at site 3 which serve to relieve ditch of excess flow.**

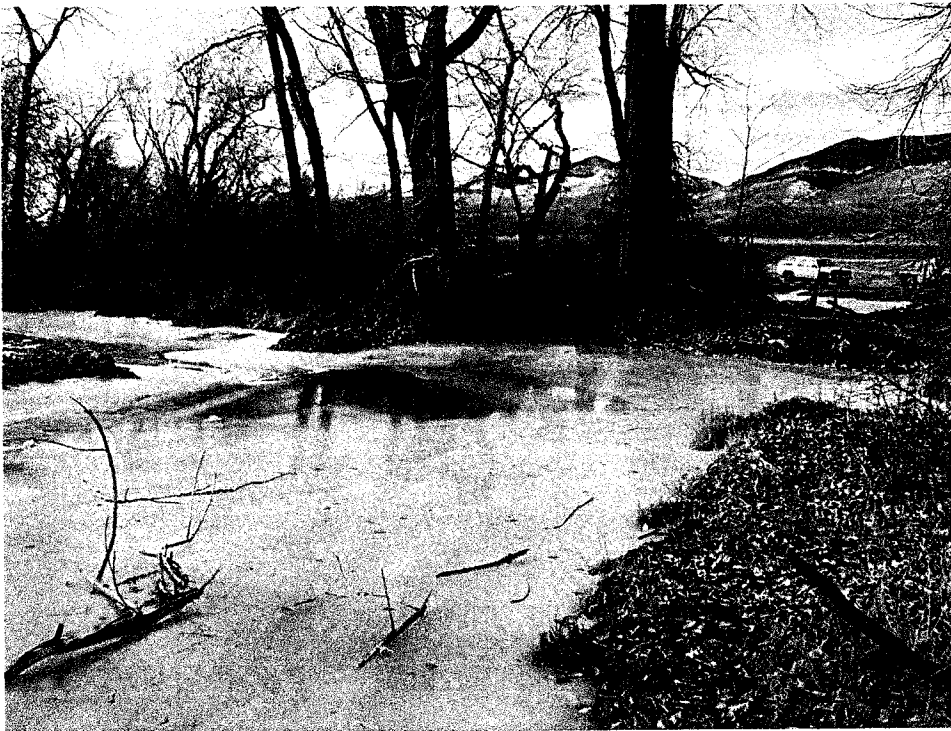
**Site 4. Headgate at top of ditch is in danger of washing out. Design will provide for fish passage and modification of site will reduce danger to floaters.**
